Australian Government  
Australian Transport Safety Bureau

# MH370 - Definition of Underwater Search Areas

3 December 2015

**ATSB Transport Safety Report**  
External Aviation Investigation  
AE-2014-054  
3 December 2015 (updated 10 December 2015)

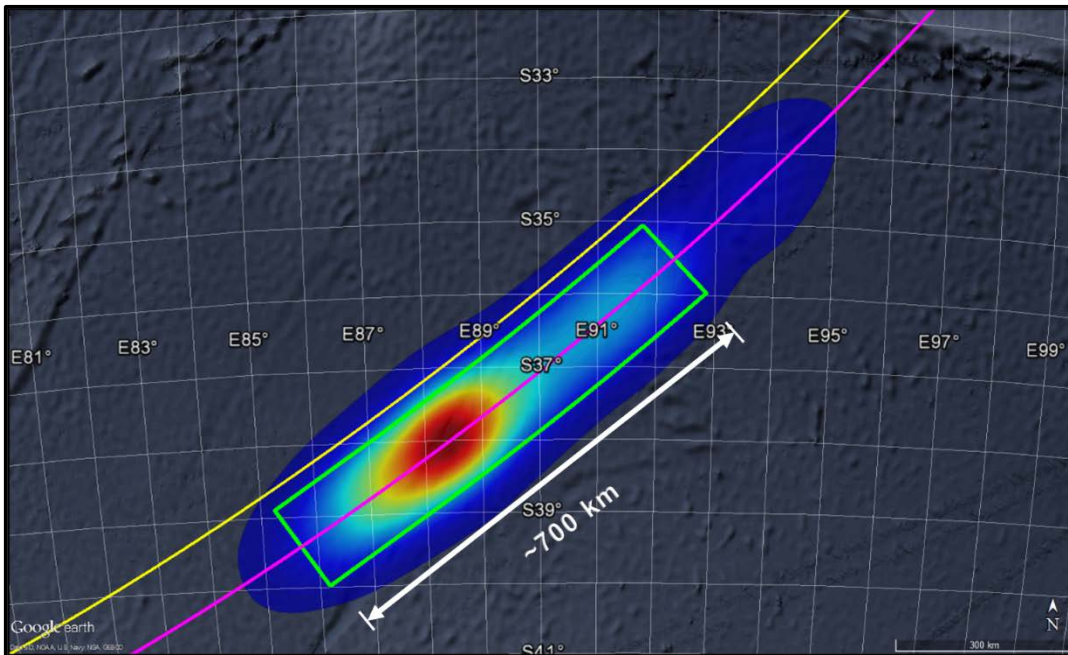
**Figure 1: Probability distribution of the location of MH370**

Figure 1 is a graphical representation of the results from the DST Group analysis combined with the ATSB end-of-flight scenario. The colours in the area represent the different location probabilities as follows:

The yellow and pink lines are the 6th and 7th arcs respectively. The green line outlines the main area of interest representing approximately 90% of the PDF.

The probability distribution of the location of the aircraft is shown in Figure 1.

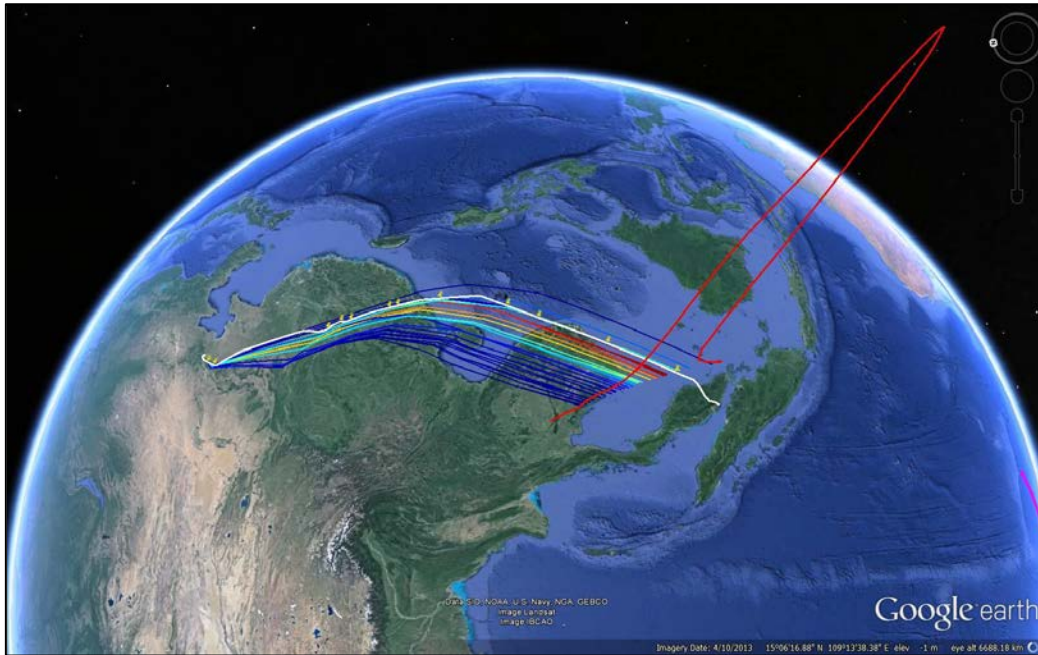
**Figure 2: Analysis results for route flown by the accident aircraft on 7 March 2014 from Beijing to Kuala Lumpur.**

*Figure 2 – Pictured are the solution tracks in the colour representing their probability. The analysis results (PDF) is shown in red. The height of the PDF represents the resulting probability of the aircraft crossing that point. The white line indicates actual aircraft path.*

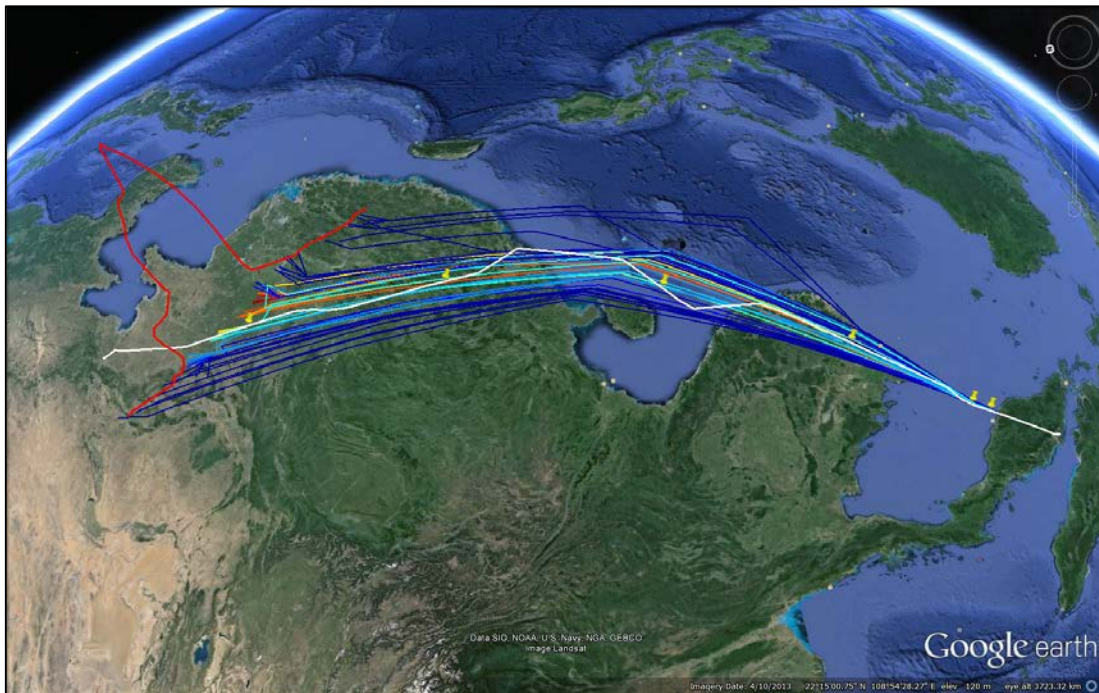
**Figure 3: Analysis results for route flown by the accident aircraft on 6 March 2014 from Kuala Lumpur to Beijing.**

*Figure 3 – Pictured are the solution tracks in the colour representing their probability. The analysis results (PDF) is shown in red. The height of the PDF represents the resulting probability of the aircraft crossing that point. The white line indicates actual aircraft path.*

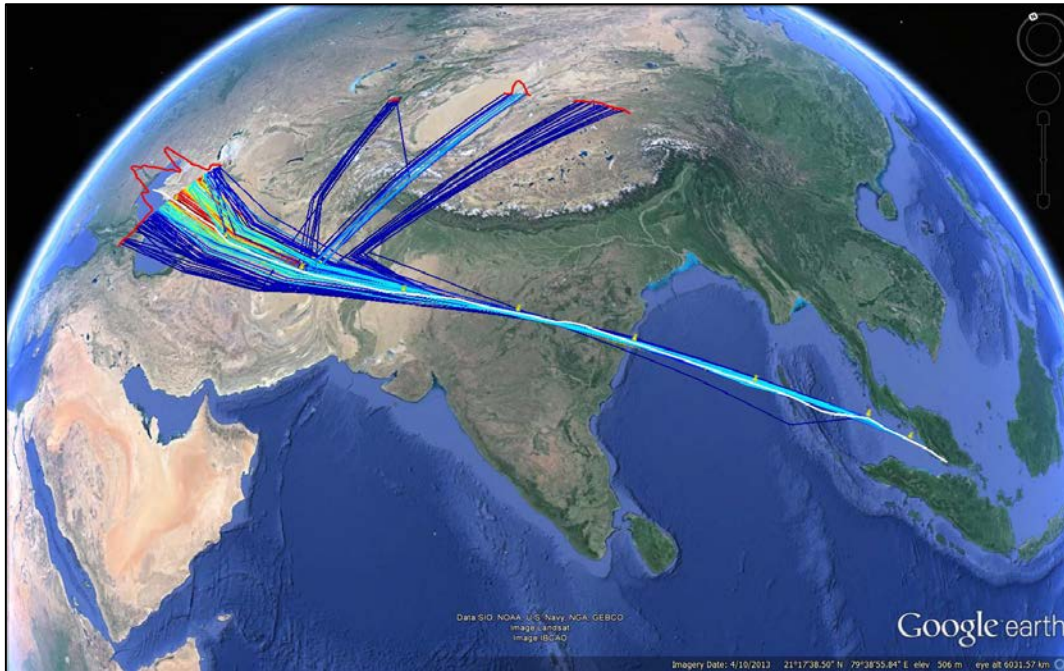
**Figure 4: Filter estimate for route flown by the accident aircraft on 26 February 2014 from Kuala Lumpur to Amsterdam.**

*Figure 4 – Pictured are the solution tracks in the colour representing their probability. The analysis results (PDF) is shown in red. The height of the PDF represents the resulting probability of the aircraft crossing that point. The white line indicates actual aircraft path.*

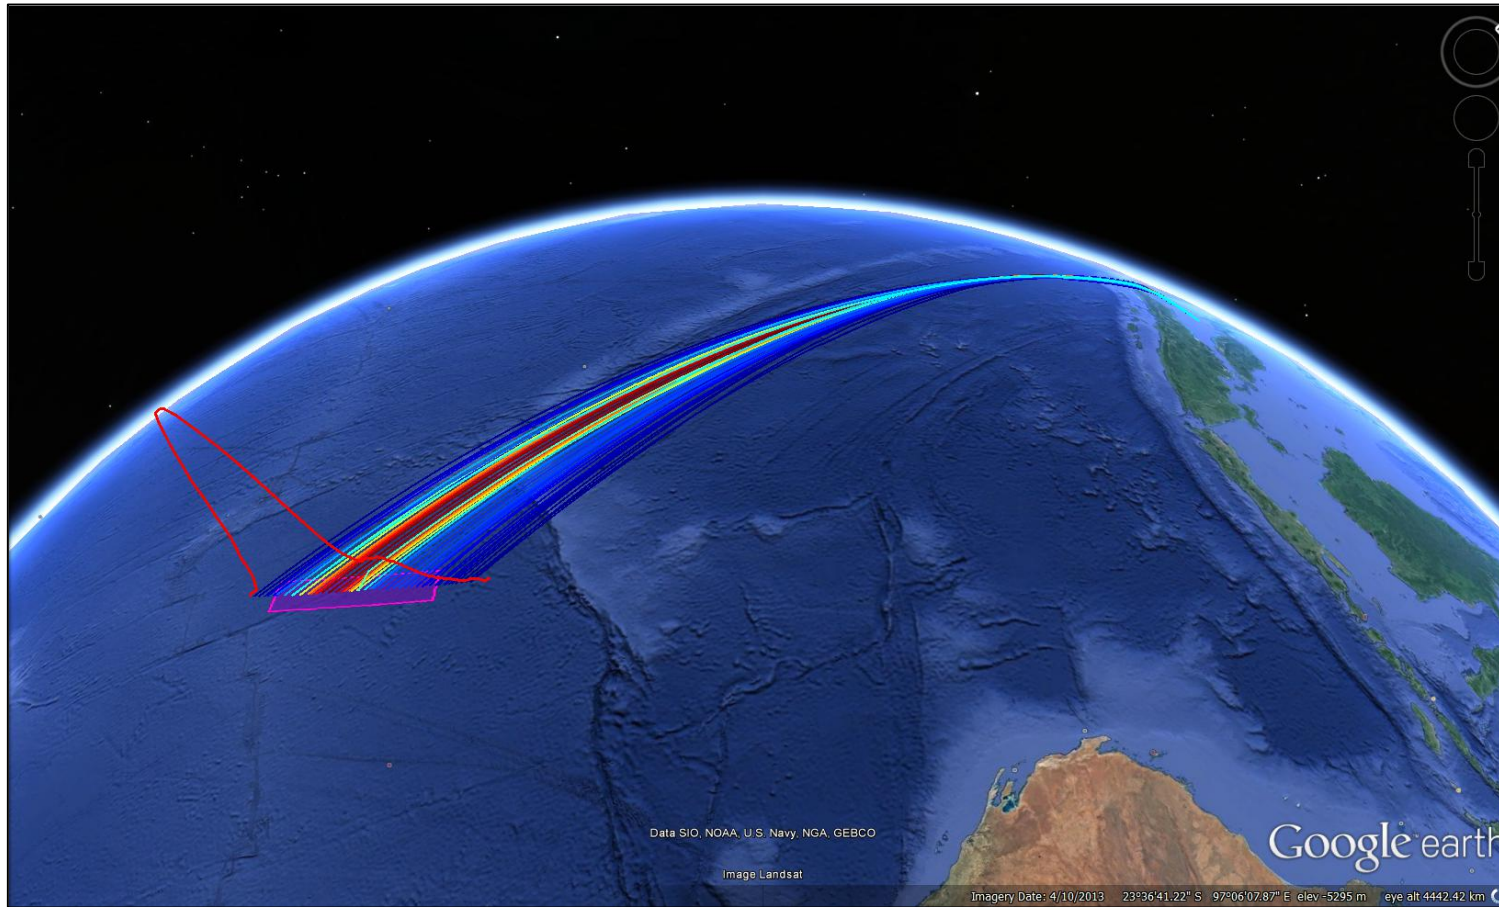
Figure 5: Analysis results for MH370

Figure 5 – Pictured are the solution tracks and the resulting PDF, on the 7<sup>th</sup> arc, from the DST Group analysis of MH370. The solution tracks are shown in the colour which represents their probability. Red is high probability, blue is low probability. An indicative search area covering approximately the top 90% of solutions is shown in pink.

Applying the analysis to the data from MH370 yielded the solution paths and corresponding PDF illustrated in Figure 5.

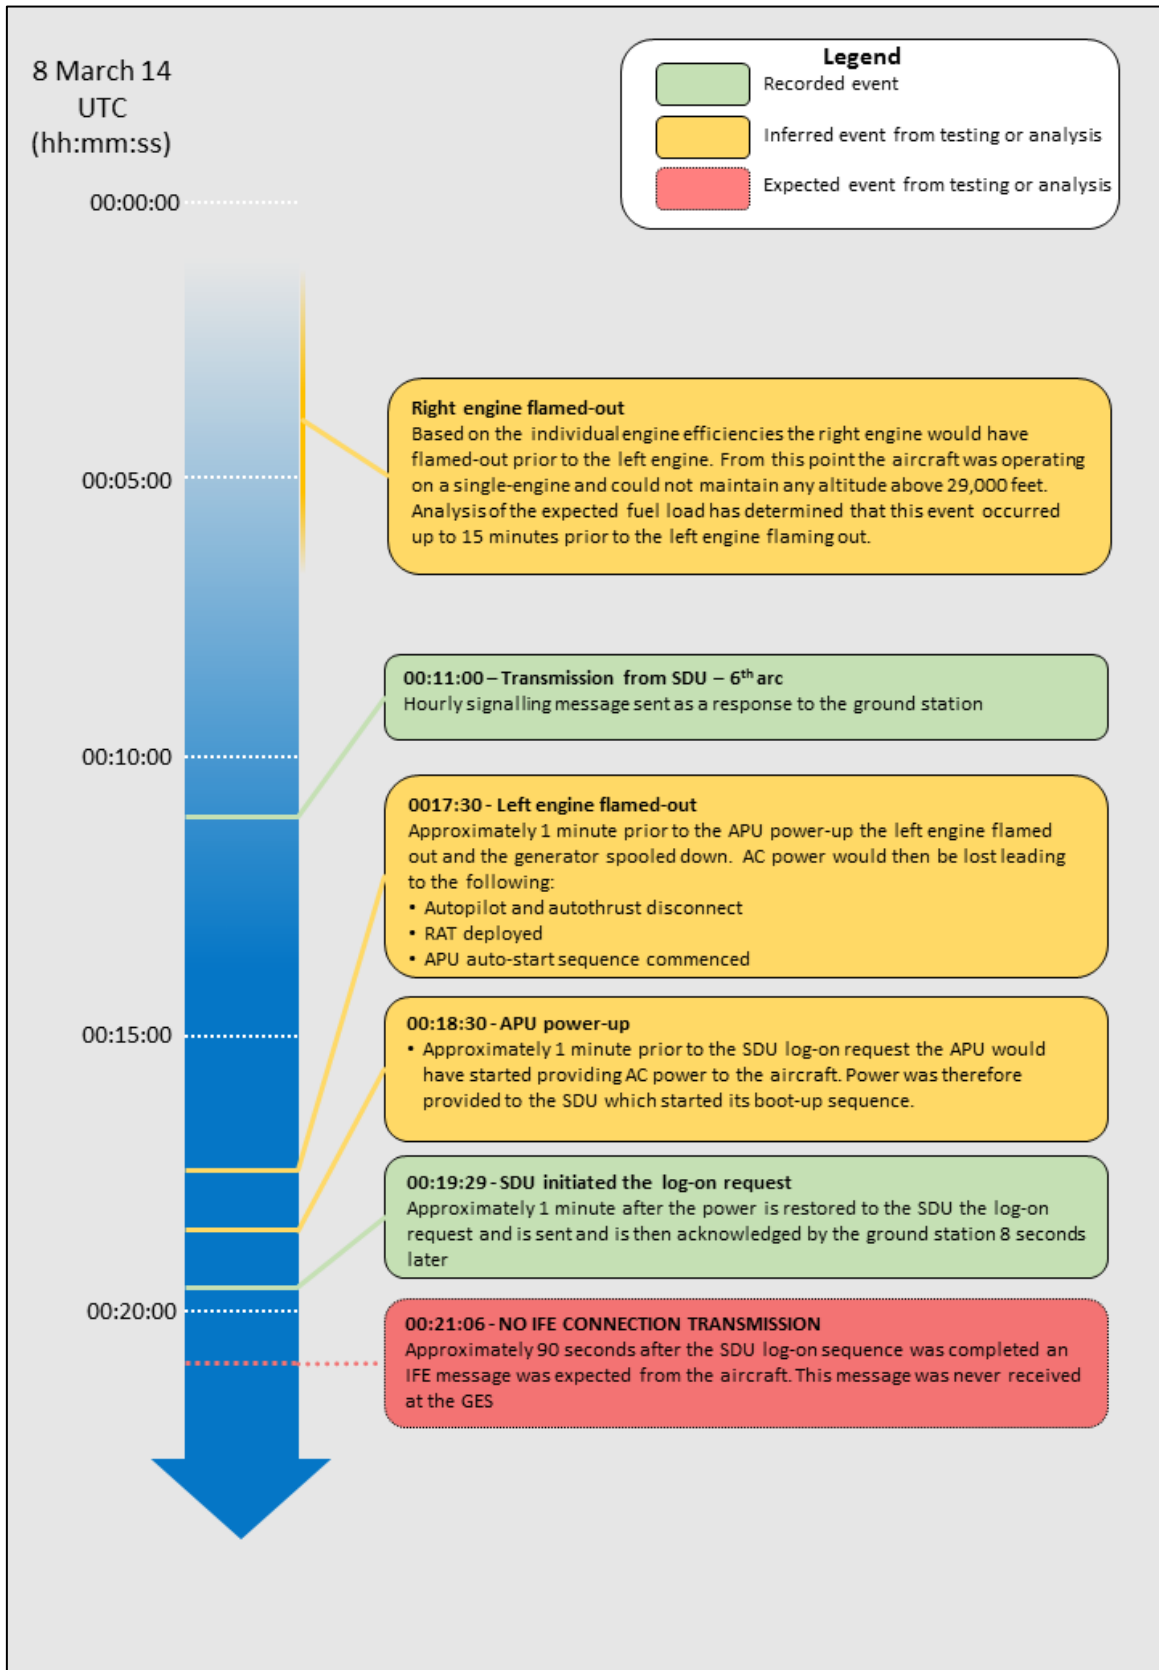
Figure 6: End of flight sequence

A small amount of fuel (30 lbs) is available to the APU fuel inlet after the left engine flamed-out. Assuming small pitch attitude changes and positive acceleration forces, this fuel would be sufficient to supply the APU for the period required by the SDU to initiate a log-on request (around 2 minutes). In this configuration the sequence is shown in Figure 6.

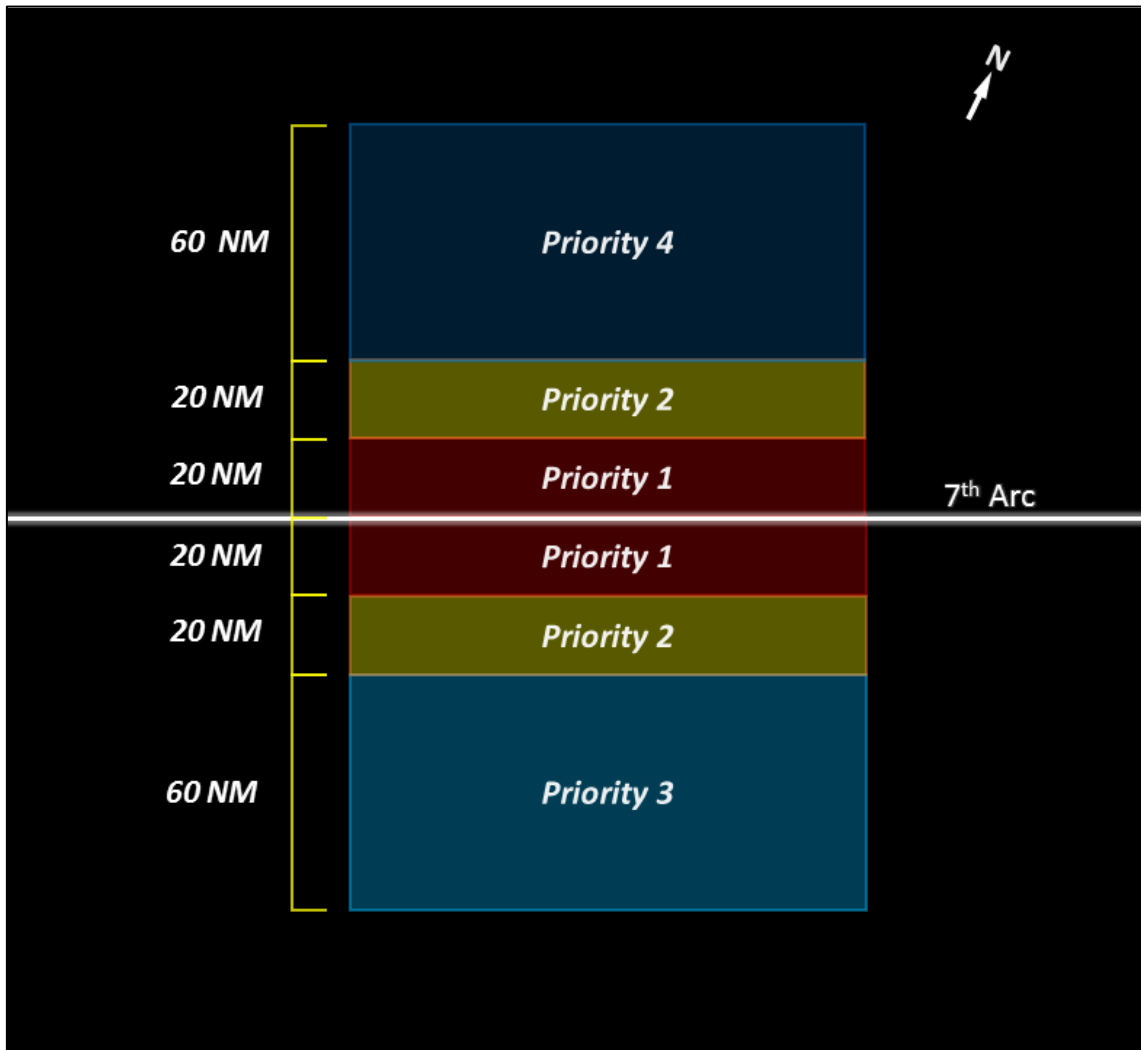
Figure 7: Search area width priorities

Figure 7 – The identified priorities for searching relative to the 7<sup>th</sup> arc are shown in this figure. These can be interpreted as the probabilities of finding the aircraft in these locations based on the current assumptions about the end-of-flight scenario. Note that due to assumptions made by the analysis, Priority areas 3 and 4 are significantly lower probability as they rely entirely on a controlled glide flight scenario.

The results of the DST Group analysis, in conjunction with the priority widths from Figure 7, were used to produce a distribution in two dimensions of the likely aircraft location Figure 9. The colours in Figure 9 represent different probabilities, dark blue is the lowest probability and dark red indicates the highest probability.

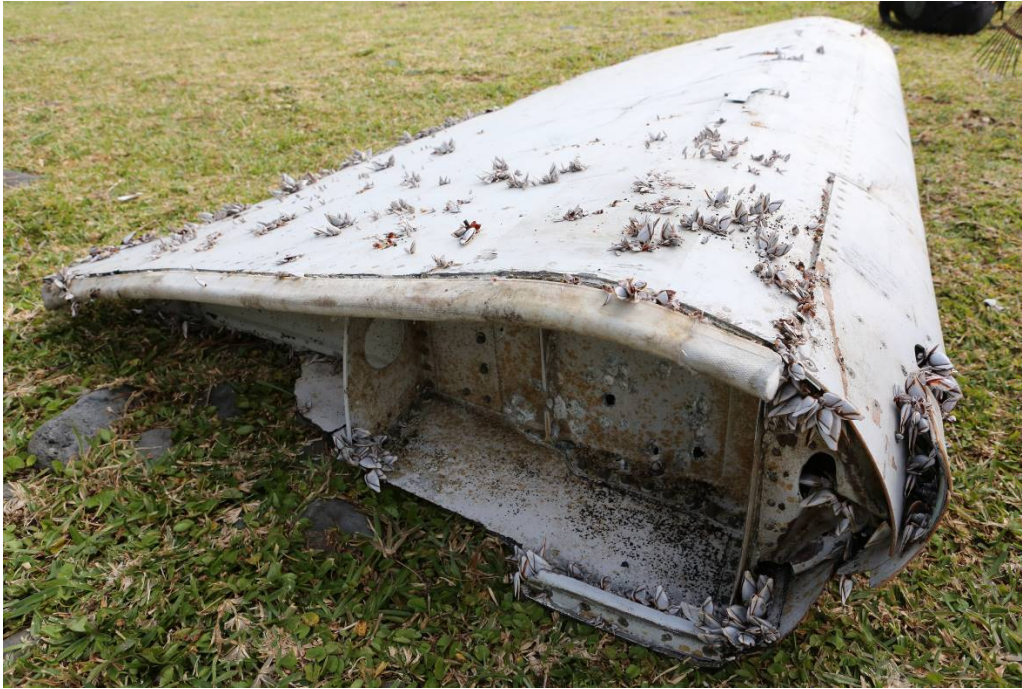
**Figure 8: Flaperon recovered from Reunion Island on 29 July 2015**

*Figure 8 – The flaperon recovered was a part of the flight control system from MH370. Barnacles are visible on the debris from the months of floating in the ocean. The location of the recovered debris is consistent with drift modelling predictions of objects starting in the areas identified as possibly containing MH370.*

On July 29 2015, a flaperon was recovered from Reunion Island. This flaperon was later confirmed as being from 9M-MRO.

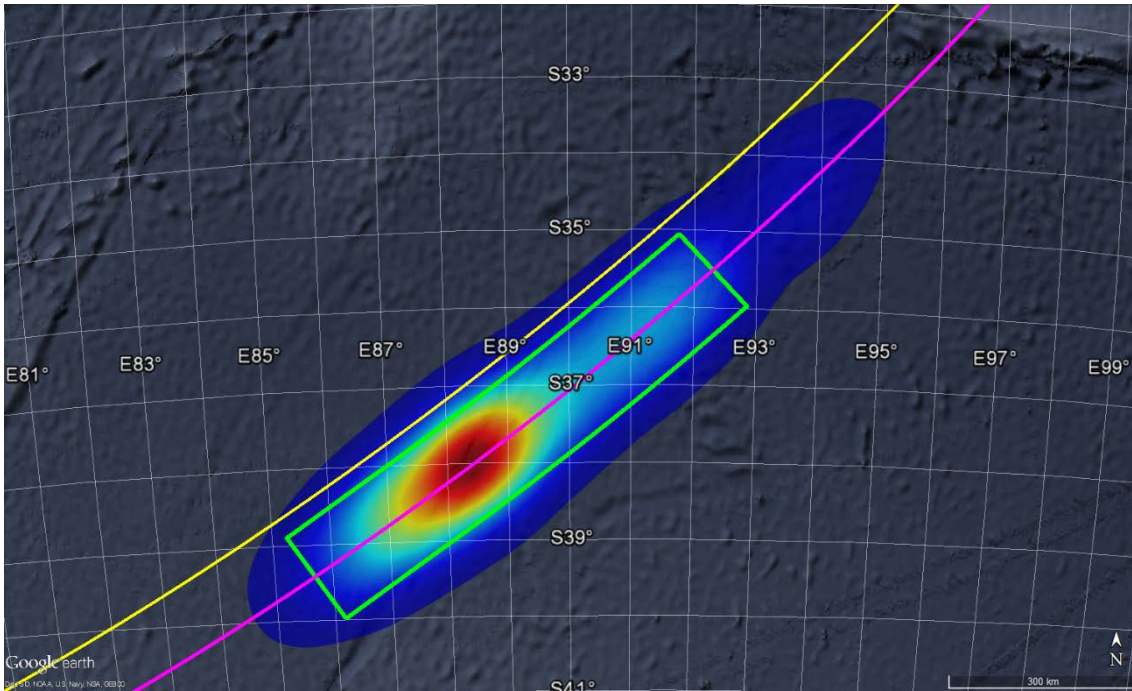
**Figure 9: Probability of the location of MH370**

Figure 9 is a graphical representation of the results of the DST Group analysis with the ATSB end-of-flight scenario. The colours in the area represent the different location probabilities as follows:
